# DIYARBAKIR SURIÇİ URBAN PROTECTED SITE BANNED AREA TECHNICAL ANALYSIS REPORT 17 JANUARY 2020

Union of Chambers of Turkish Engineers and Architects, Chamber of Architects Diyarbakir Branch

## B. TECHNICAL ANALYSIS

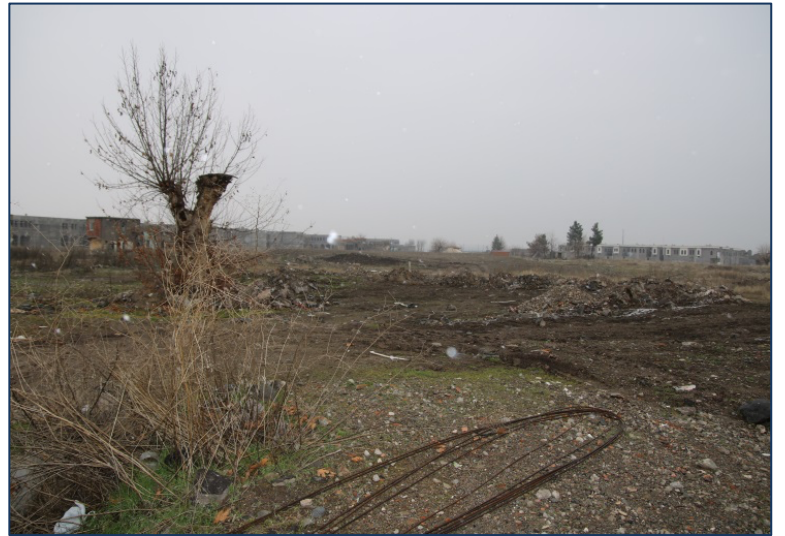
1. It is confirmed that 43 (forty-three) registered buildings, which were determined to be demolished according to the Document No. 19661 issued by Diyarbakir Provincial Directorate of Environment and Urban Planning on 03.12.2019, are completely gone, including their remains. Integrity of the remaining registered buildings is disrupted due to careless approach to these buildings during demolition process, the urban protected site has become a flat ground, street, block and lot boundaries are not conserved, building materials of the demolished or damaged registered buildings are not found on the site and environmental buildings identified in CDP 12 are not conserved but destroyed completely.

Photo 2: General view from the Location No. 1 shown in Photo 1.

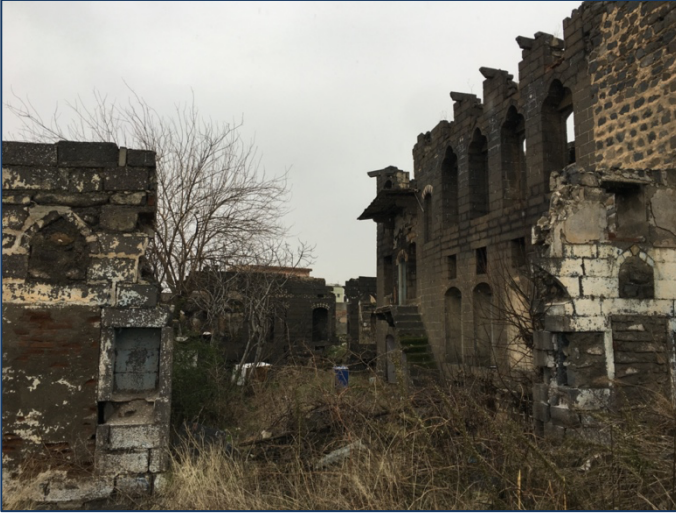
*Photo 3: Current status of the registered building on Block No. 30 and Lot No. 2-3*

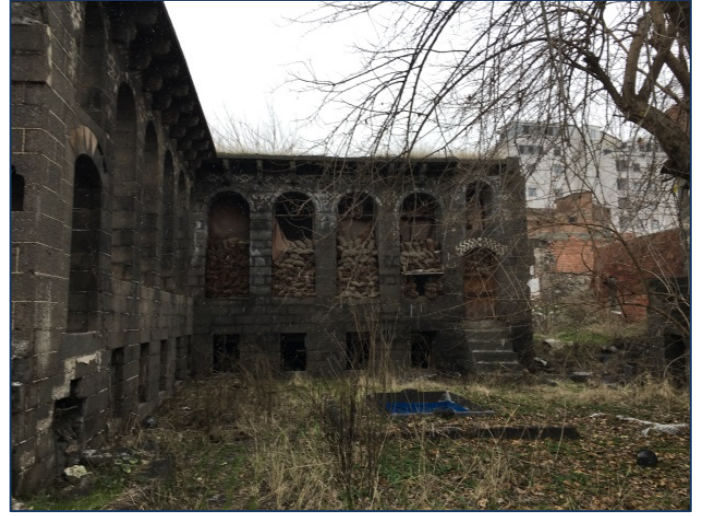
*Photo 4: Current status of the registered building on Block No. 385 and Lot No. 14*

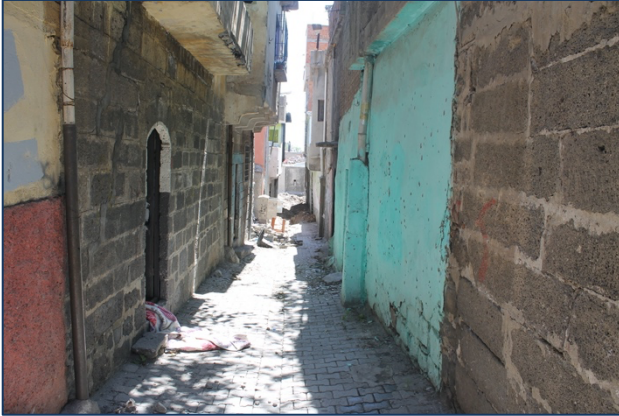
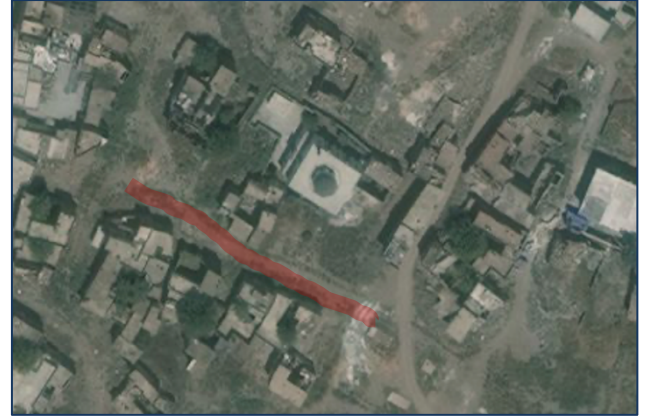
Photo 11: Photo of Cemal Yılmaz Neighborhood, Şair Sırrı Street taken in May 2016 (on the left), satellite image of the street after demolition for urban transformation purposes after the conflicts taken on 8 March 2020 (on the right)

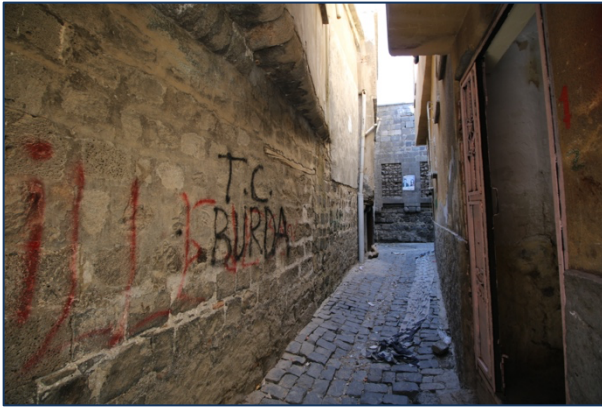
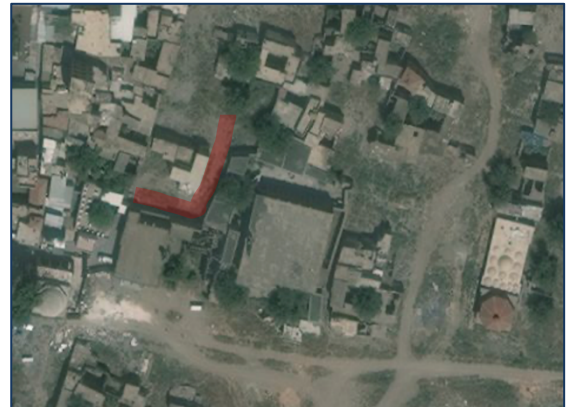
Photo 12: Photo of Savaş Neighborhood, Şeftali Street taken in June 2016 (on the left), satellite image of the street after demolition for urban transformation purposes after the conflicts taken on 8 March 2020 (on the right)

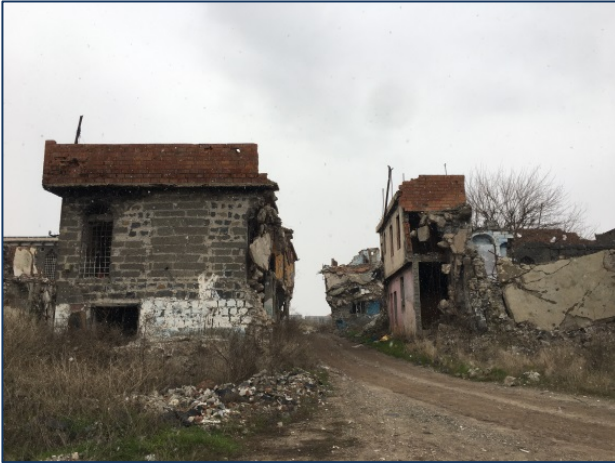
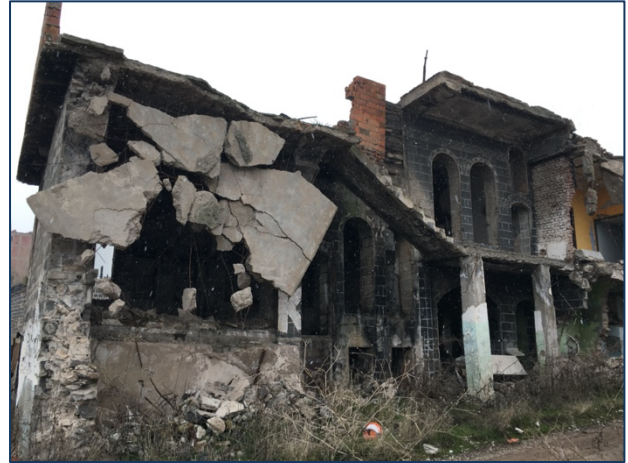
4. Some of the registered buildings that are examples of Civil Architecture and the registered buildings to be conserved due to their environmental value are demolished and used as an actual road for vehicles. In addition, it is determined that many streets, especially Yenikapi Street that has been transformed from a 7-meter street preserving its characteristic structure to a 15-meter street, have been extended against the traditional urban plan of Sur and as a result, many registered buildings and buildings with environmental value are demolished.

*Photo 13: Current status of the registered buildings on Block No. 673 and Lot No. 98-99 that has lost its texture as a result of street expansions.*

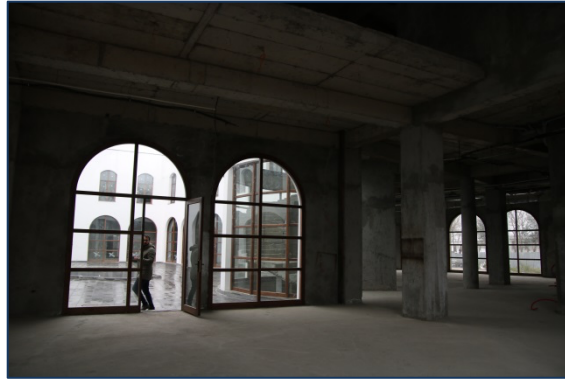
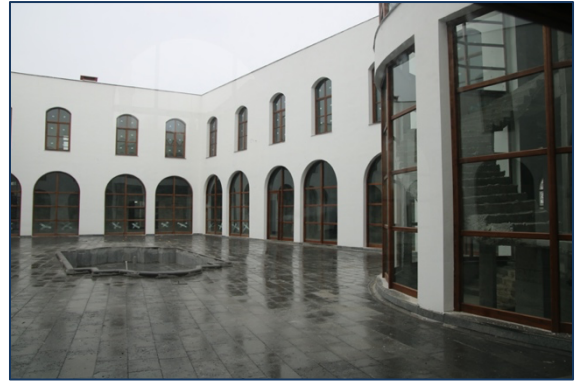
5. Following the destruction, it is seen that the block, lot and street boundaries that had been preserved for hundreds of years were changed, footprints and story heights allowed for the lots are increased to allow construction of commercial buildings and characteristic street texture, integrity and authenticity of Sur, an urban protected area, are completely destroyed with the Conservation Development Plan (CDP) 2016 Revision.

Photo 16: New commercial buildings built through amalgamation as a result of changing the original building block form

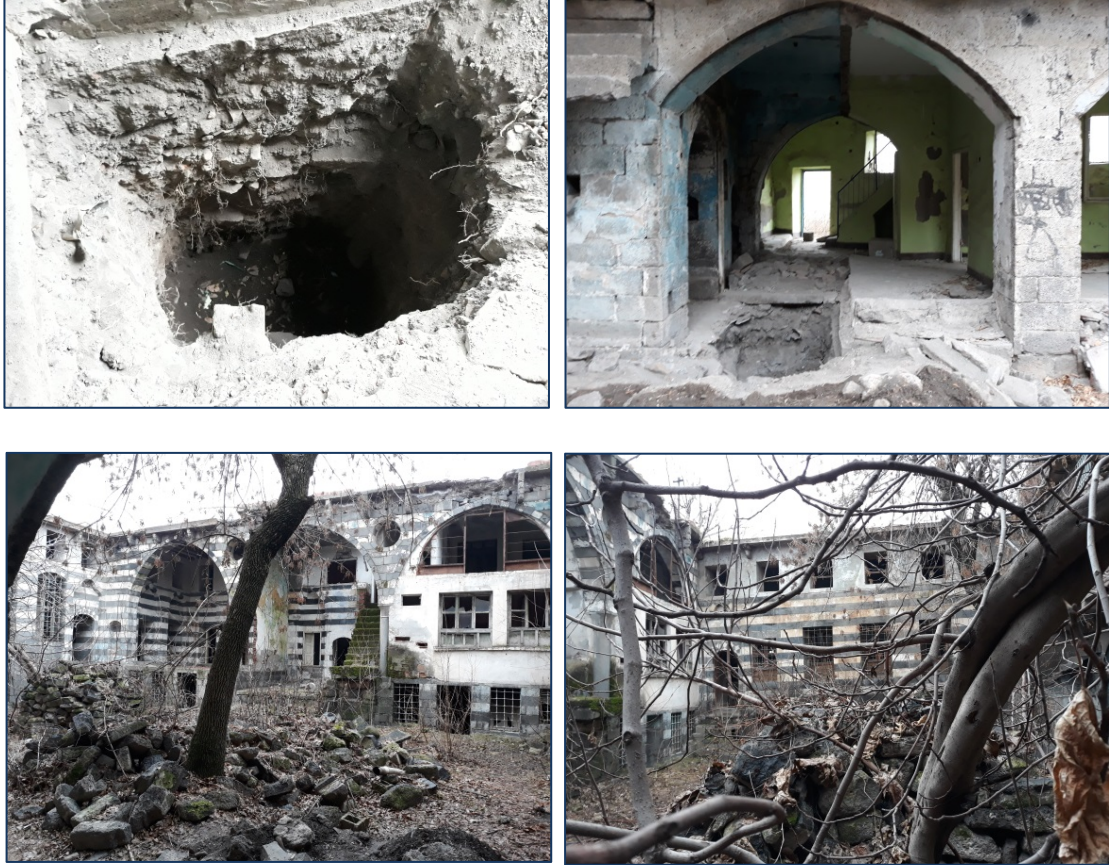
6. It is observed that many excavations were made for treasure hunting purposes and some of the buildings were damaged due to this reason on the site, which has been under blockade and for which entry and exit are under control of security forces since March 2016, after the end of conflicts in the area.

*Photo 17: 2016 Unlicensed excavation made on Block No. 190 and Lot No. 3-16*

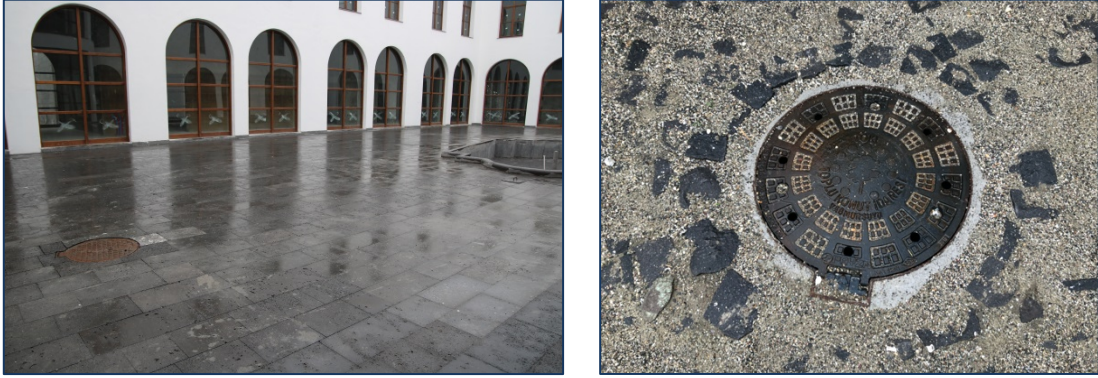
7. It is seen that up to 4-meter-deep excavations were made for infrastructure of new buildings on the site and archeological layers in Sur were damaged. Original boundaries of streets, building blocks and lots are damaged and construction activities are carried out with a partitive approach. This also can be seen from the fact that the manholes and telecommunication inspection holes on the original streets were stuck in courtyards of some of the buildings.

*Photo 18: New building and manhole in the courtyard*

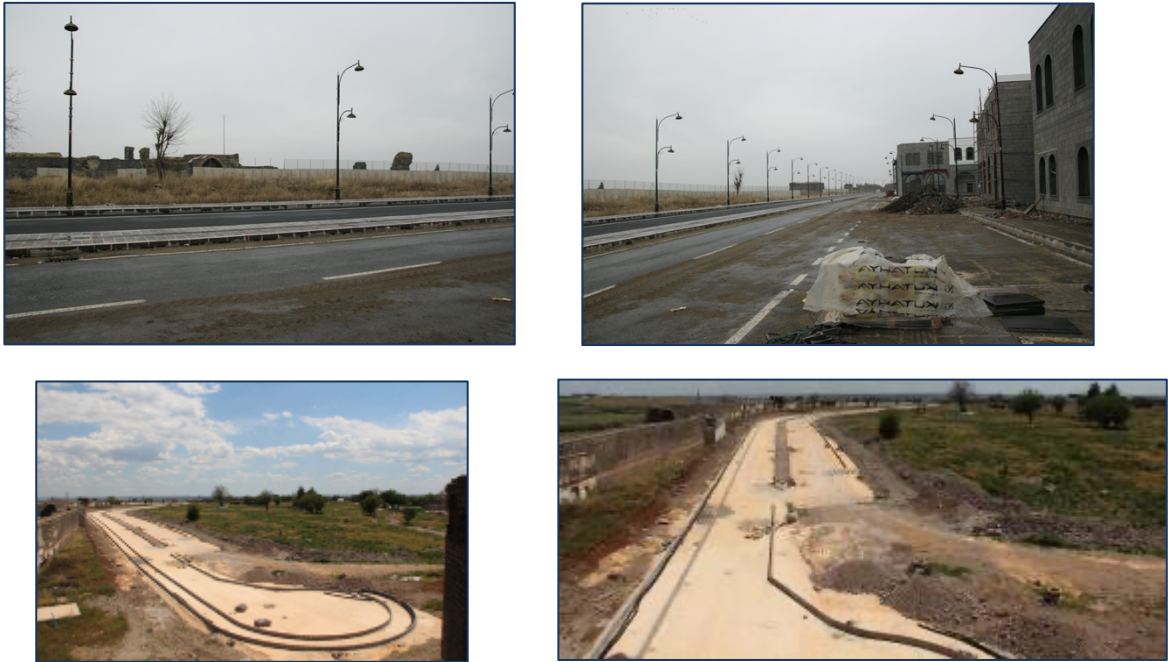
8. It is seen that the heavy blocks of concrete that disrupt the scene and the perceptual continuity of the city wall, which is listed as a World Heritage, are still present. In addition, construction of the double lane asphalt road from the Keçi Bastion to İçkale (Inner Fortress) Walls right next to the city walls indicates that a heavy traffic flow is projected for the area. It is undeniable that the vibrations from the traffic right next to the eastern walls, which is the weakest link of the city wall, poses a great risk and will even cause collapse of the walls.

*Photo 19: Concrete blocks left next to the walls and new asphalt road.*

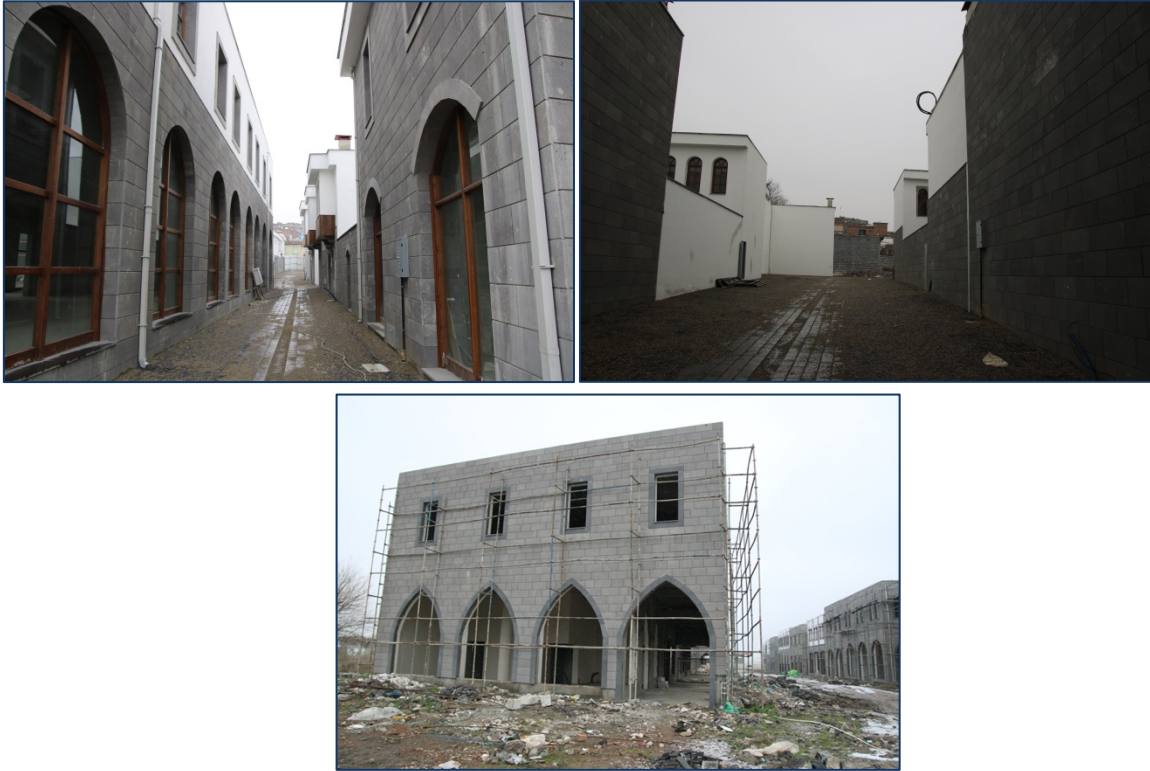
9. It is seen that the new buildings on the site contradict the original and traditional Diyarbakir architecture, are fully basalt covered reinforced concrete buildings and lack the most prominent characteristics of traditional Sur architecture such as bay window, basalt, wide courtyards, doors and windows facing the streets, courtyard wall details and ponds. In addition, it is seen that the basalt glued on the facades of new buildings on the site are not indigenous to Diyarbakir. It is determined that the new buildings with wide doors and windows facing the streets with large faces and porches completely contradict the original texture of the streets. In addition, it is determined that there are wide, painted and plastered facades, which are not included in the original texture of the streets.

*Photo 20: Facades of new buildings*

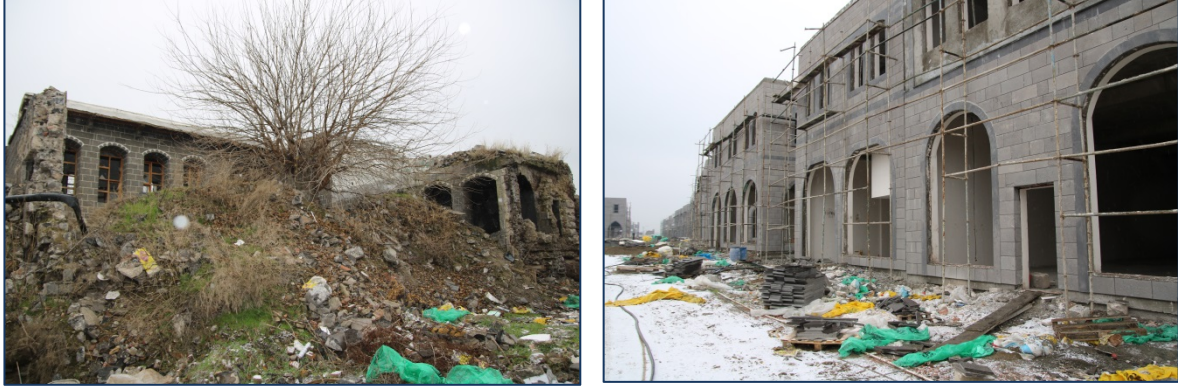
10. Original elevations are not followed and 1,5-meter elevation differences are created, as seen in Muallak Street where the Protestant Church is located. Likewise, there are many paddings consisting of debris and building materials up to 4 meters created by means of construction equipment in Yenikapi Street.

*Photo 21: Yenikapi Street new buildings and registered building facades*

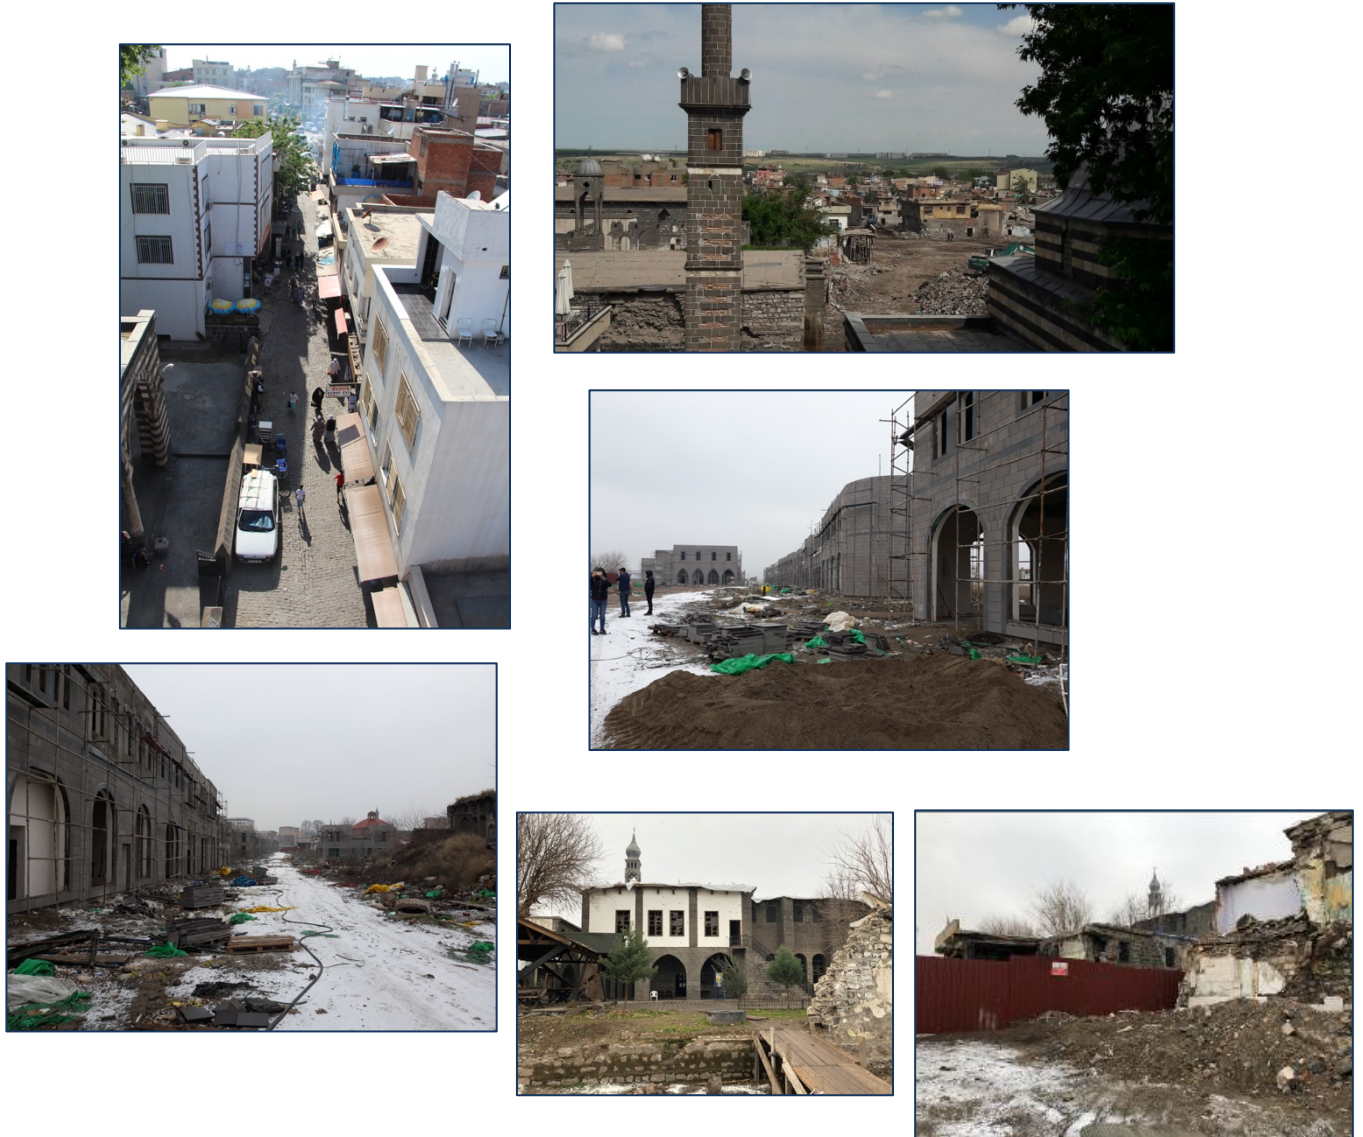
*Photo 22: Former state of Yenikapi Street and the buildings constructed after urban transformation and registered building facades.*
