# DIYARBAKIR SURIÇİ URBAN PROTECTED SITE BANNED AREA TECHNICAL ANALYSIS REPORT 17 JANUARY 2020

Union of Chambers of Turkish Engineers and Architects, Chamber of Architects Diyarbakir Branch

## B. TECHNICAL ANALYSIS

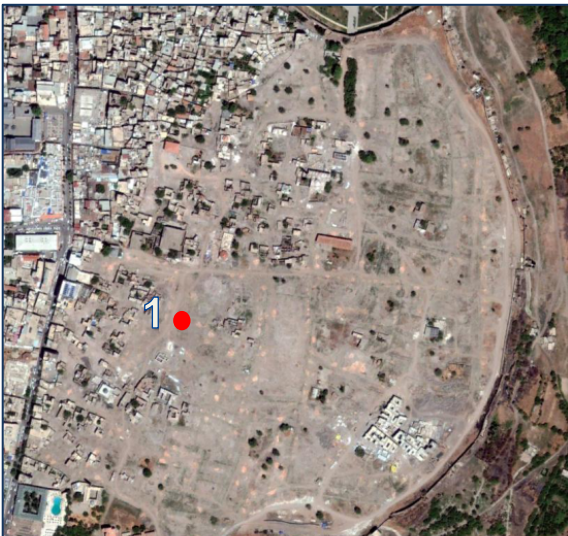
Photo 1: Satellite image of the 6 neighborhoods under blockade taken on 11.07.2017

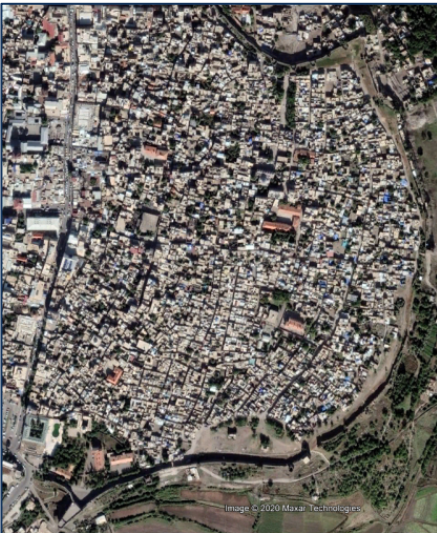
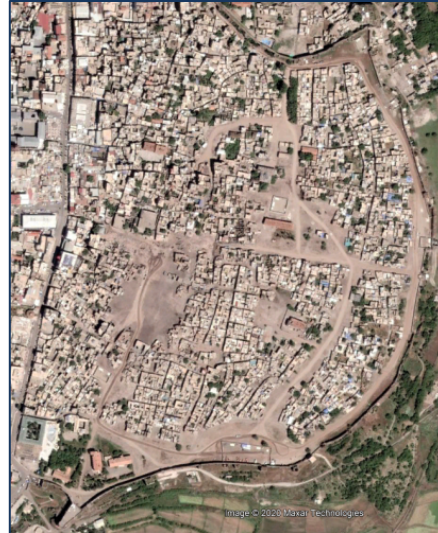
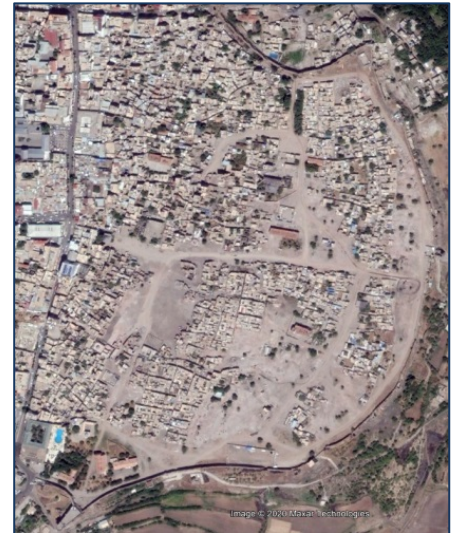
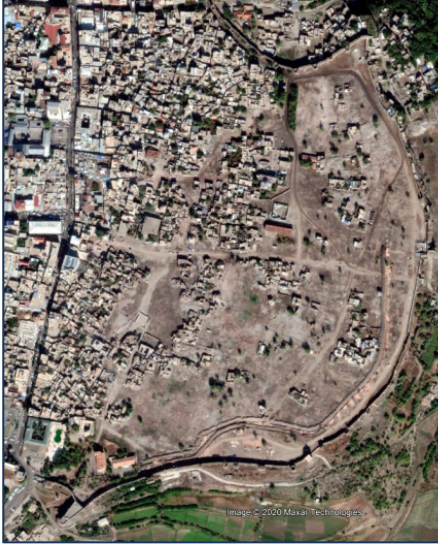
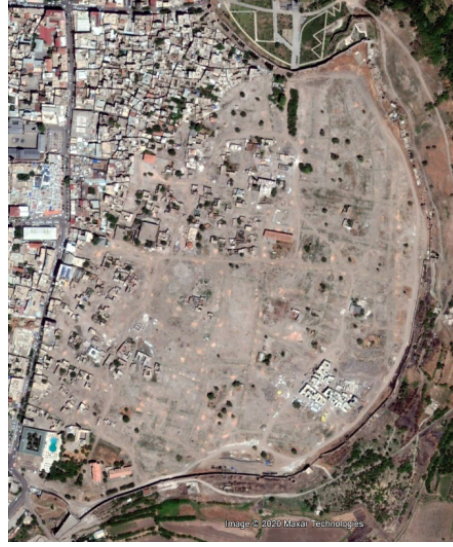
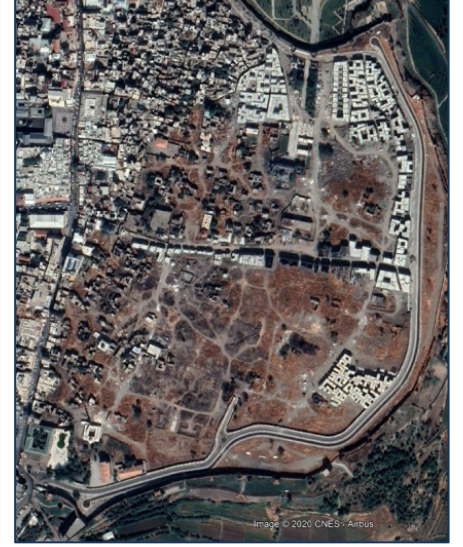
2. Our committee has determined from the studies on satellite images taken on different dates that, although the buildings on the site were damaged from heavy weaponry, the destruction on the site has become irreversible after initiation of demolition activities with construction equipment. Likewise, it is seen from the report dated July 2016 issued by our Damage Determination Committee established by the Ministry of Culture as well as the attached lists and photos of the registered buildings on the site in addition to the satellite images that tens of streets, which did not receive a single bullet on its buildings, have become a flat ground as a result of the demolition activities.

*Photo 5: Satellite image of the 6 neighborhoods under blockade taken on 08.11.2015*

*Photo 6: Satellite image of the 6 neighborhoods under blockade taken on 10.05.2016*

*Photo 7: Satellite image of the 6 neighborhoods under blockade taken on 29.07.2016*

Photo 8: Satellite image of the 6 neighborhoods under blockade taken on 08.11.2016

Photo 9: Satellite image of the 6 neighborhoods under blockade taken on 11.07.2017

Photo 10: Satellite image of the 6 neighborhoods under blockade taken on 09.10.2019

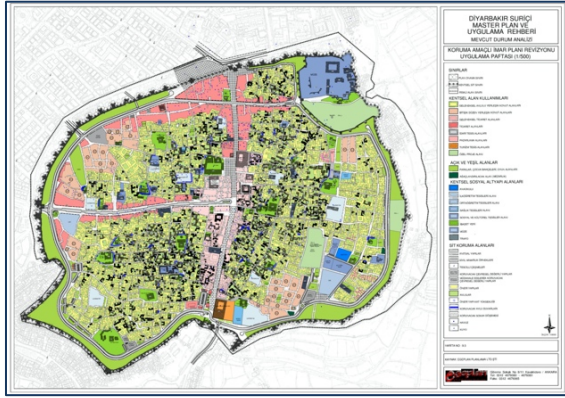
Photo 14: 2012 Conservation Development Plan

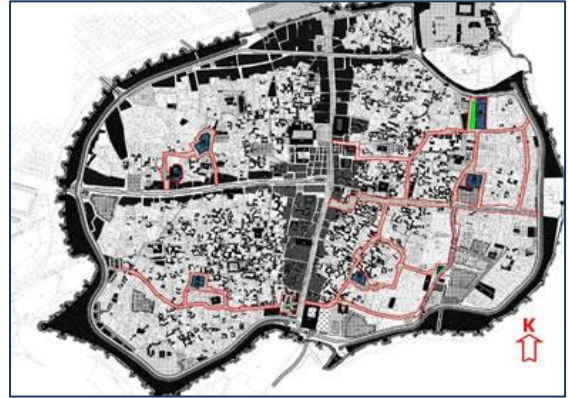
5. Following the destruction, it is seen that the block, lot and street boundaries that had been preserved for hundreds of years were changed, footprints and story heights allowed for the lots are increased to allow construction of commercial buildings and characteristic street texture, integrity and authenticity of Sur, an urban protected area, are completely destroyed with the Conservation Development Plan (CDP) 2016 Revision.

Photo 15: Conservation Development Plan 2016 Revision
